**DEPARTMENT OF FORESTRY AND FIRE PROTECTION
OFFICE OF THE STATE FIRE MARSHAL
RUBEN GRIJALVA, STATE FIRE MARSHAL**

SUBJECT: NOTICE OF VIOLATION AND CIVIL PENALTY
Walnut Creek Pipeline Explosion and Fire (11-09-04)
SFM #277 – LS-16 (Concord to San Jose Pipeline)

Pipeline Failure Investigation Report

Pipeline System: LS-16 (Concord to San Jose) Operator: Kinder Morgan Energy Partners
Location: Walnut Creek, Contra Costa County, CA Date of Occurrence: 9 November 2004
Medium Released: Premium Gasoline Quantity: 564 Barrels

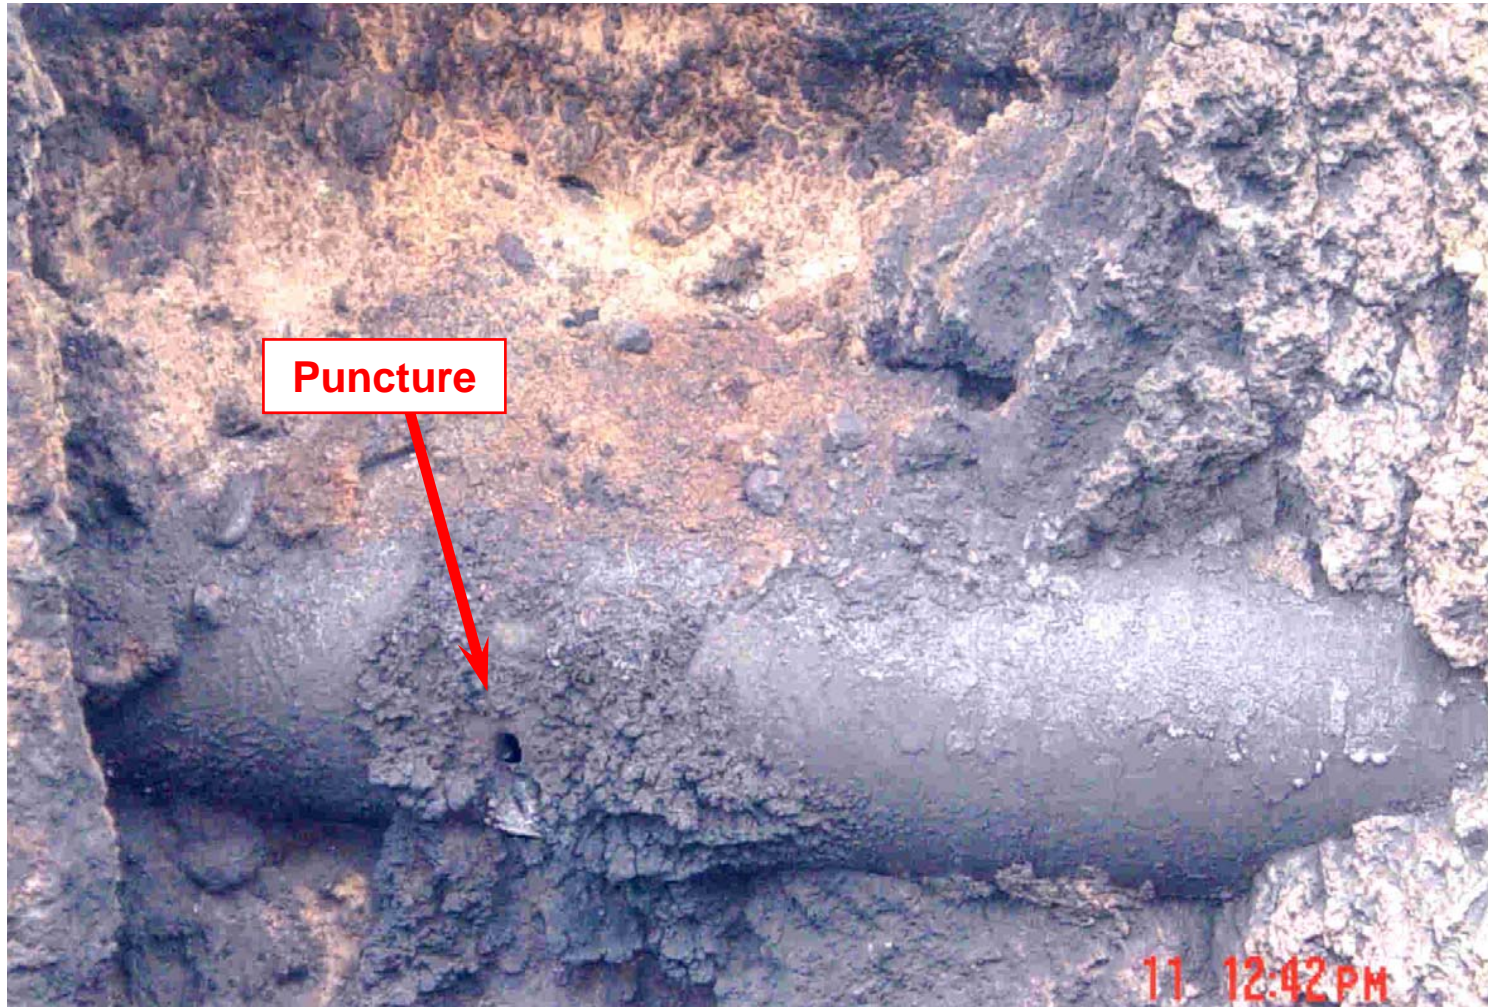
bucket. Premium gasoline, which was being shipped at the time from Kinder Morgan's Concord Pump Station to their San Jose Terminal, streamed from the pipeline into the surrounding area. The hole made by the excavator was approximately one-inch in diameter (about the size of a quarter). The pressure for LS-16 at the failure site at the time of the accident was 973 PSI.

Photo A: Kinder Morgan LS 16 pipeline with through-wall puncture.

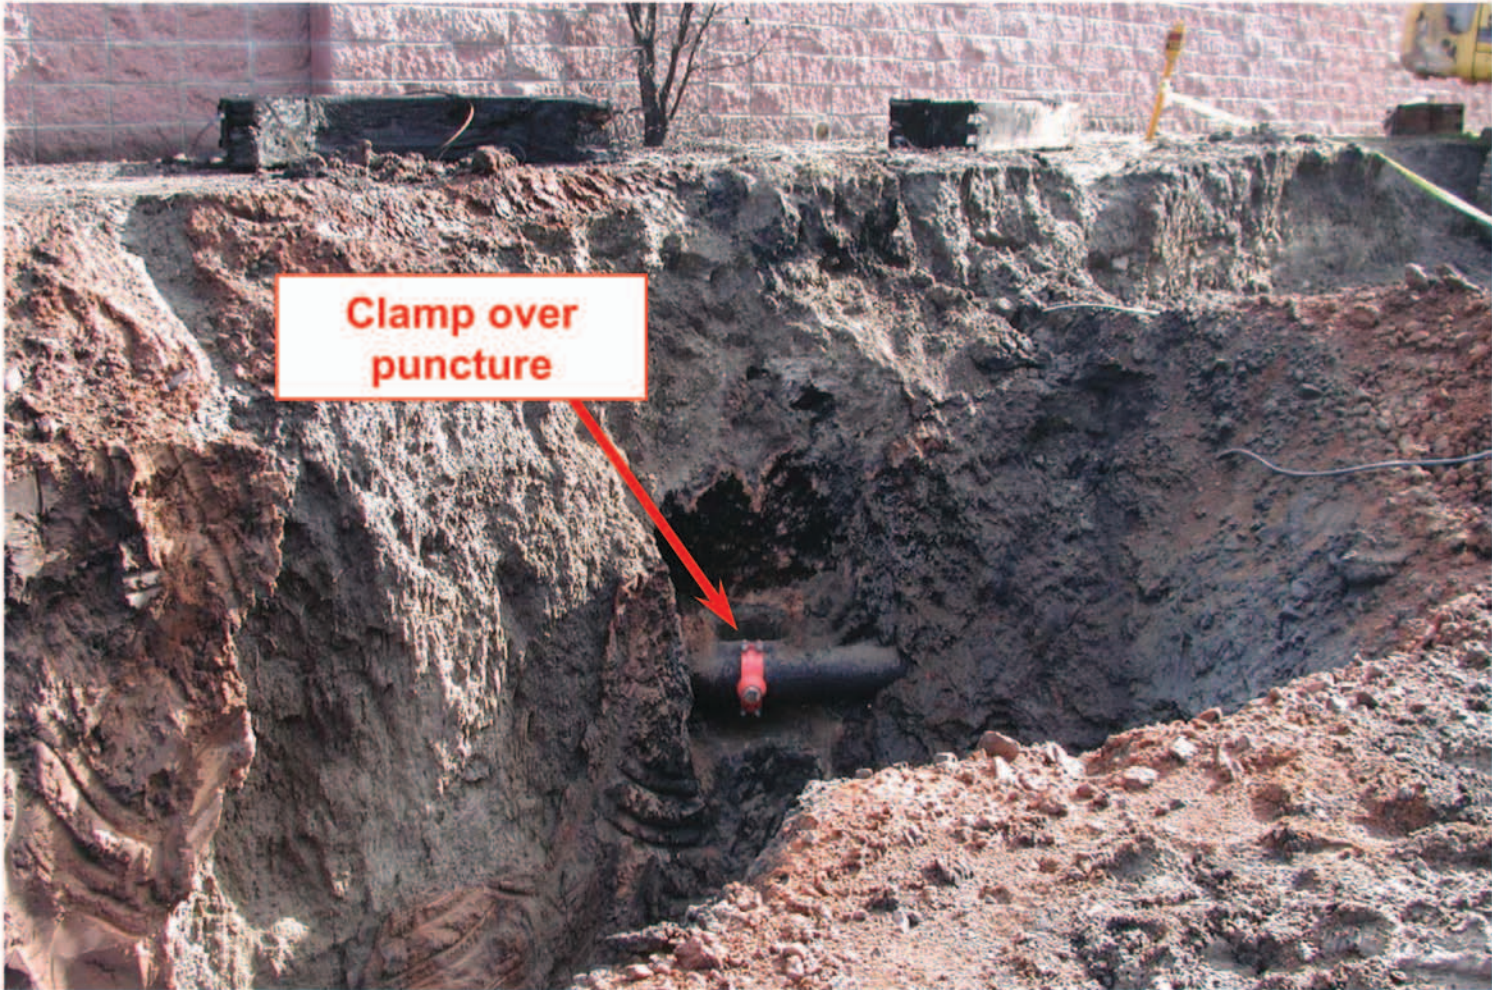
If Yes - Method: Puncture was covered with a temporary clamp and wrapped in plastic.				
In Custody of: Anamet, Inc., Hayward, CA - metallurgical test laboratory (for CalOSHA)				
Develop a sketch of the area including distances from roads, houses, stress inducing factors, pipe configurations, etc. Bar Hole Test Survey Plot should be outlined with concentrations at test points. Direction of Flow.				
<i>Component Failure Description</i>				<input checked="" type="checkbox"/> N/A
Component Failed: (1)				
Manufacturer:		Model:		
Pressure Rating:		Size:		
Other (Breakout Tank, Underground Storage):				
<i>Pipe Data</i>				<input type="checkbox"/> N/A
Material: Steel		Wall Thickness/SDR: 0.188 inch		
Diameter (O.D.): 10.750 inch		Installation Date: 1965 for original line 1987 for accident site section		
SMYS: 52,000 psi		Manufacturer: Unknown		
Longitudinal Seam: High Frequency ERW		Type of Coating: Polyken Tape

Photo B: Kinder Morgan LS 16 with temporary clamp over puncture.

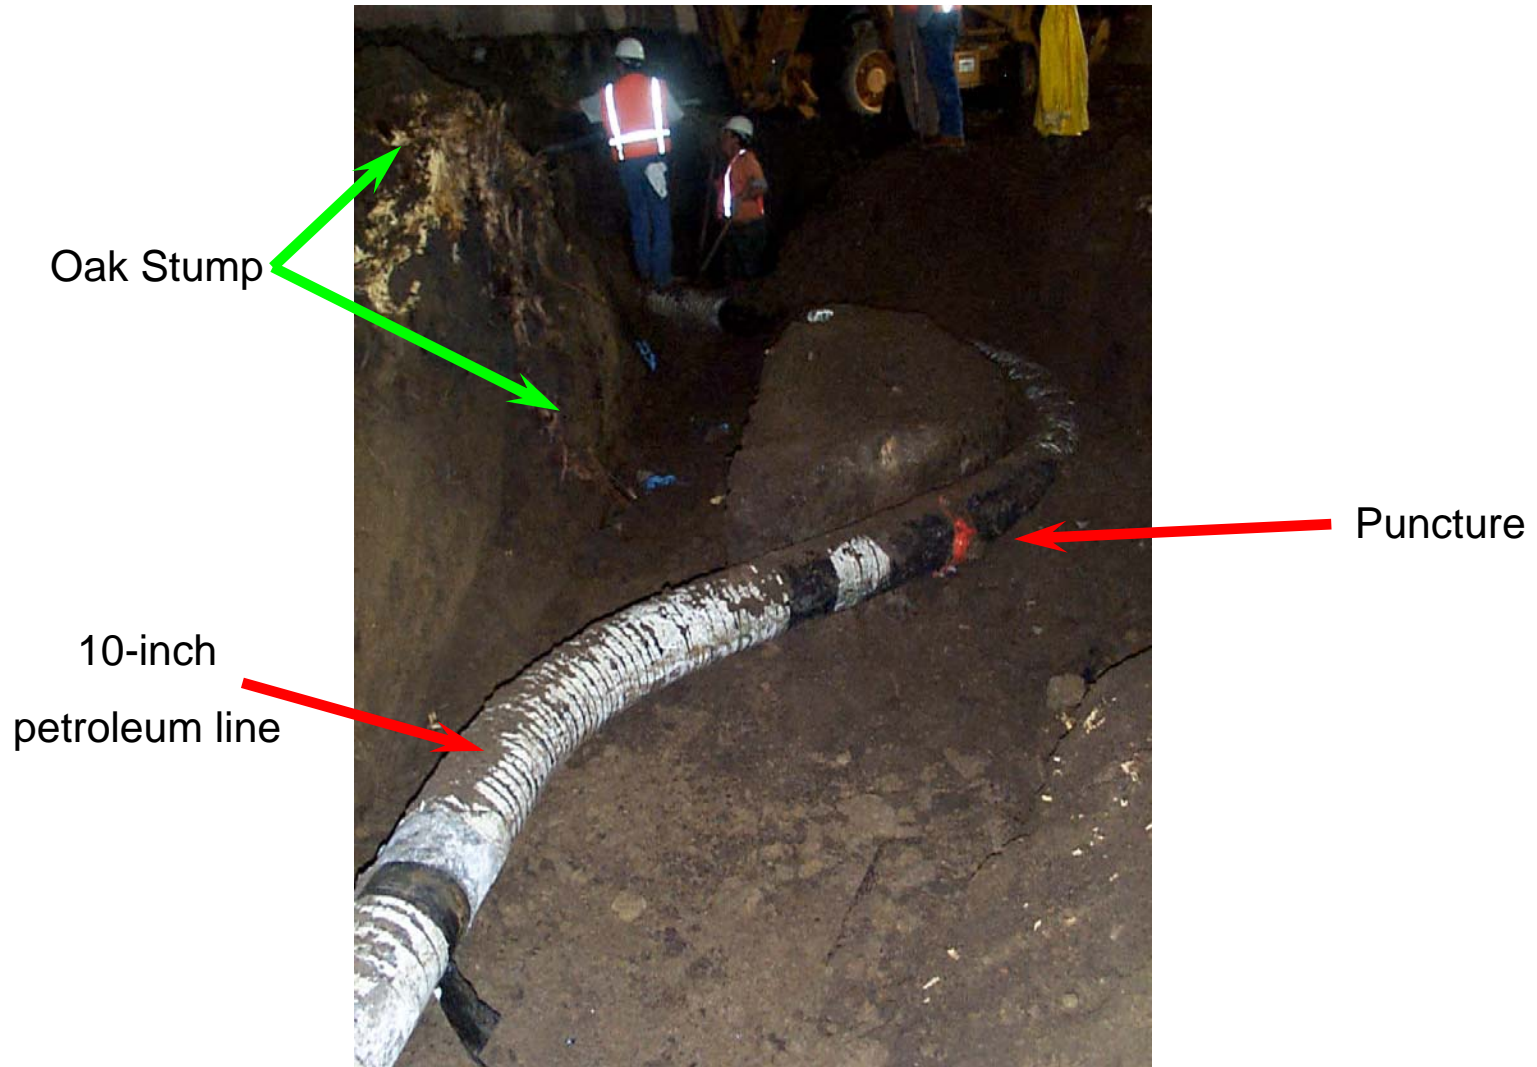
Kinder Morgan violated CFR 49 Part 195.442(a) which states: "each operator of a buried pipeline must carry out, in accordance with this section, a written program to prevent damage to that pipeline from excavation activities". Kinder Morgan did not mark the location of LS-16 as required by the company's damage prevention program and as required by Section 4216 of the California Government Code. Specifically, Kinder Morgan did not mark the approximate location of the pipeline to within 24 inches of either side of the exterior surface of the subsurface location at KM Station 447+90 to Station 448+18 (EBMUD Station $\pm 100+15$).

Photo C: Kinder Morgan LS 16 pipeline “offset” shown in the original location going around the oak tree stump.

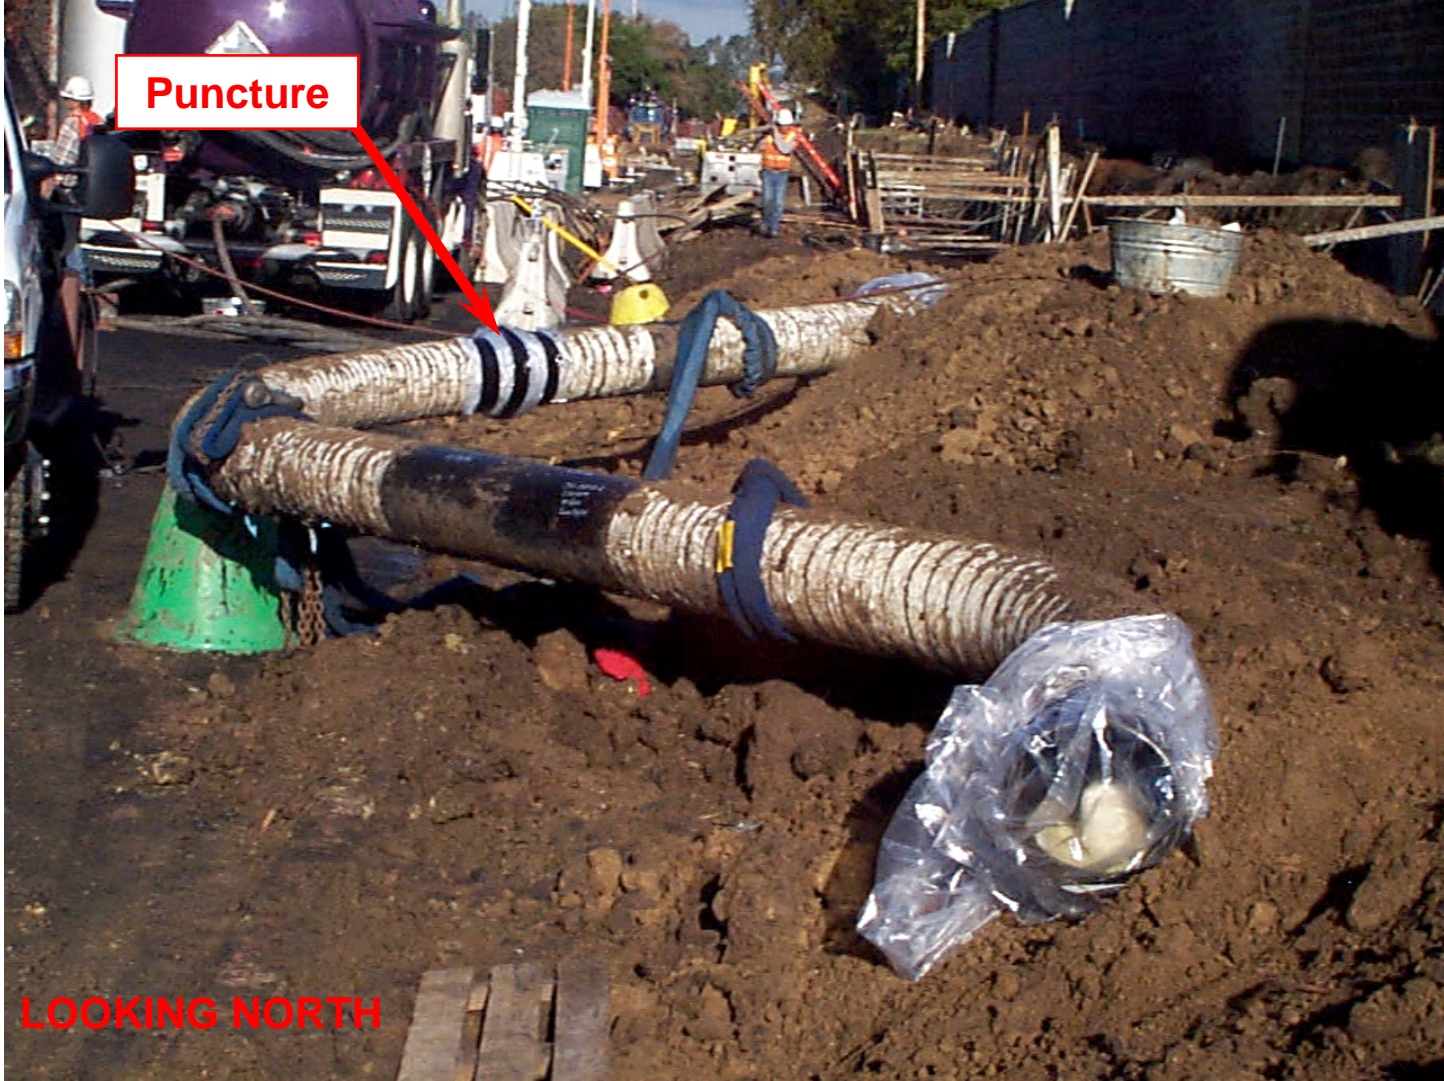
Photo D: Kinder Morgan LS 16 pipeline “offset” section removed.

At 0640 hours on 13 November 2004, the section of LS -16 containing the rupture was removed by cold cutting and saved as evidence. This pipe section was replaced by pre-tested pipe stenciled with the following information: "9-06-02" (date pipe was pressure tested); "CSFM 02-190" (the CSFM test ID number); and "10 .250 X52" (the pipe's specifications).

Two certified welders from contractor ARB welded the new pipe section in place. High Mountain Inspection Company nondestructively tested the pipe welds and at 1535 hours on 13 November 2004, High Mountain reported that the two repair welds were acceptable to API Standard 1104. The replacement pipe section was then coated with Polyken primer and double wrapped with 910 Polyken tape.

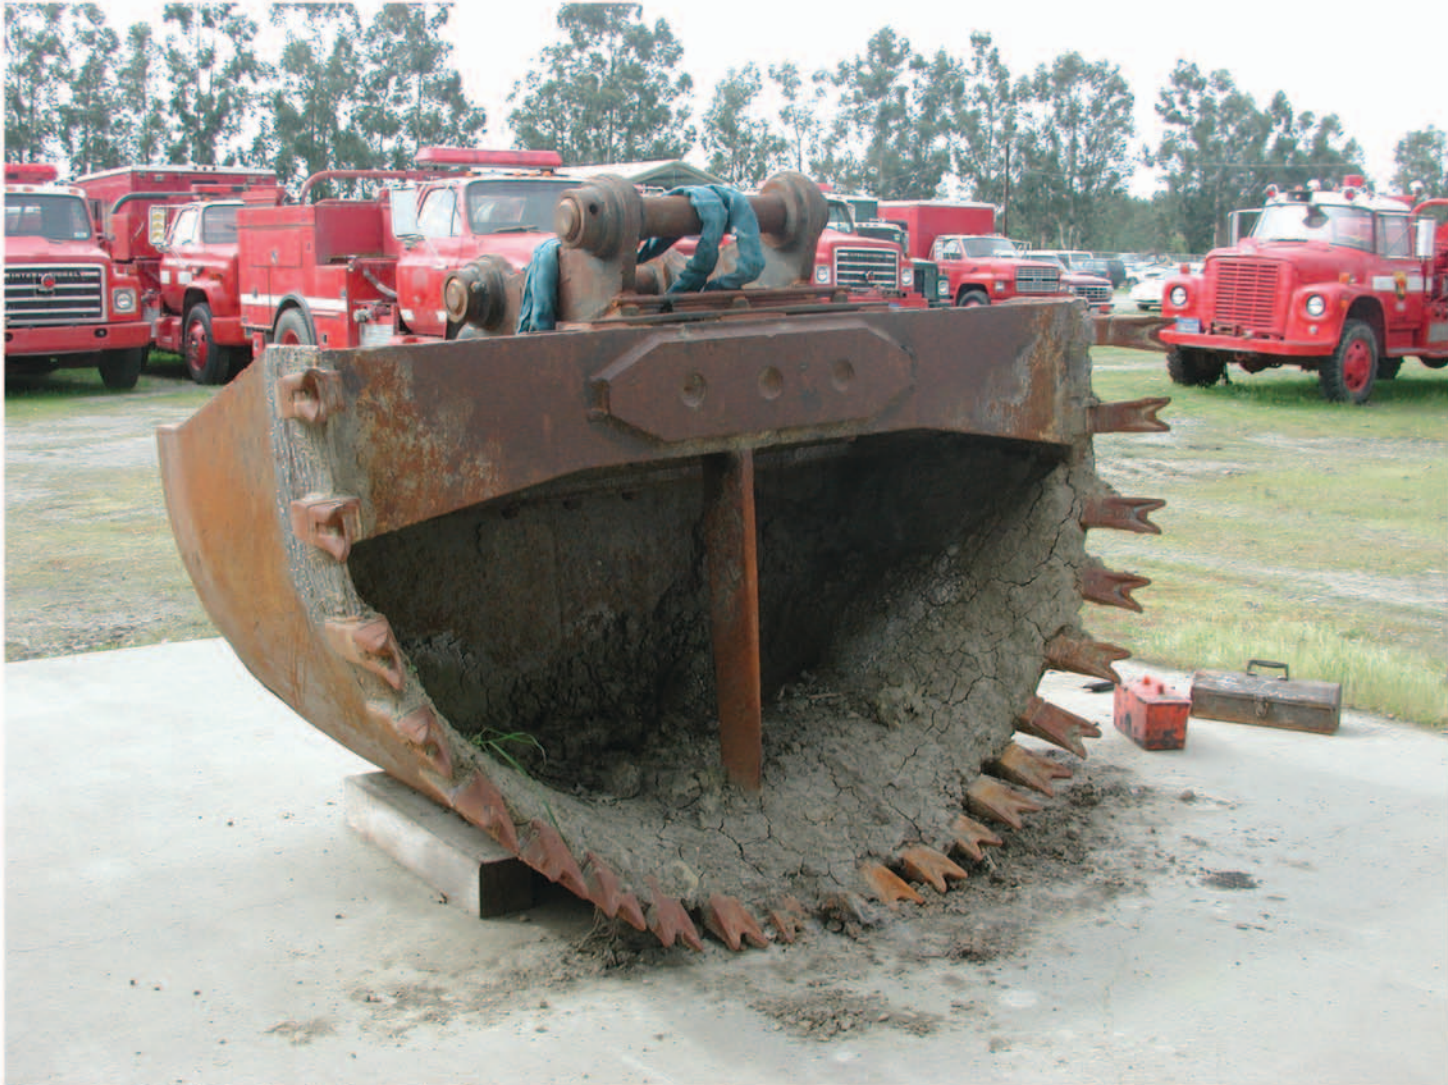
At 0700 hours, 13 November 2004, both the bucket and 30-foot section of LS-16 containing the rupture were taken into custody by SFM. The rock tooth bucket was labeled #04-5845-1; the piece of pipe was labeled #04-5845-2. Both pieces of evidence were carefully loaded and secured on an ARB trailer and taken to Anamet, Inc., a metallurgical testing lab located in Hayward, CA. where it was met by Ken Pytlewski, Director of Engineering and Laboratories for Anamet. The loading and transportation of the evidence was observed by SFM Pipeline Engineers Linda Zigler and Chuck MacDonald.

Photo E: Mountain Cascade excavator bucket with rock teeth.

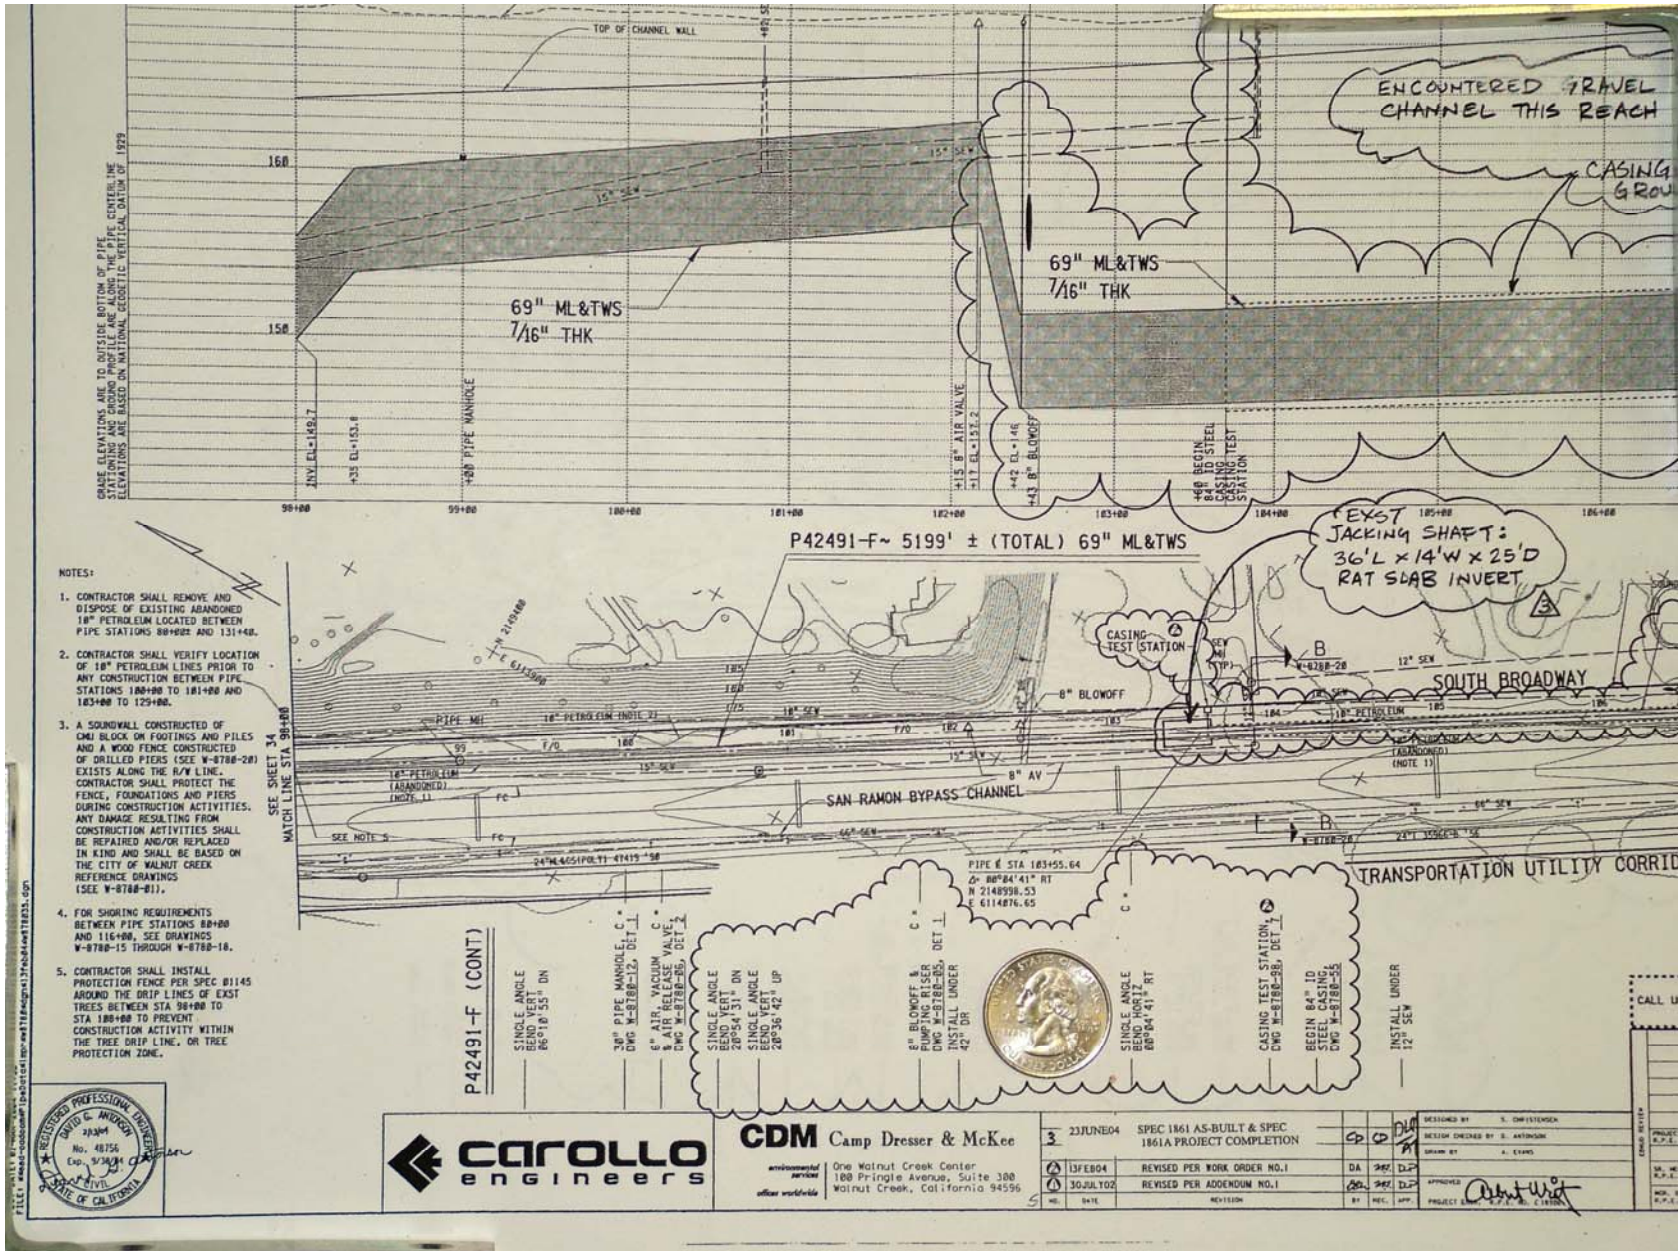
ITEM 2: Carollo Drawing 05/10/02 – Last Revision 06/23/04
(courtesy CalOSHA)

Mountain Cascade violated Section 4216.4 (a) of the California Government Code (Underground Service Alert "One Call" Law) in that the company failed to determine the exact location of the subsurface installations (10-inch pipeline) that was in conflict with the excavation. Construction drawing DWG W-8780-36, Note 2, states "Contractor shall verify location of 10" petroleum lines prior to any construction between pipe stations 100+00 to 101+00 ..." (NOTE: "Verify" in this context refers to Section 4216.4 of the California Government Code, which requires exposing the petroleum pipeline by hand tools to positively locate the line). Although the field marking of the offset was not present at time of the excavation, the location of the offset was previously provided to Mountain Cascade and was noted on their construction drawings.

EBMUD identified early on in the design process that there was a hazardous liquid pipeline in the vicinity of the proposed water line and that special measures were to be taken to prevent damage to the pipeline. EBMUD and their engineering consultants had been in contact with Kinder Morgan in October 2000 regarding general alignment and drawings of the petroleum pipeline. Kinder Morgan provided as-built drawings to EBMUD that clearly indicated the offset between Stations 100+00 and 101+00.
